Review of Risk Factors for Line 1600

Michael J. Rosenfeld, PE
February 20, 2017

REVIEW OF RISK FACTORS FOR LINE 1600

SAN DIEGO GAS & ELECTRIC COMPANY

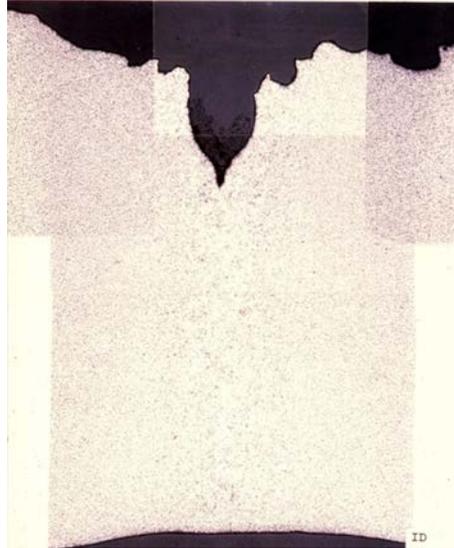
Figure 9. Selective seam weld corrosion viewed in cross section

Flash welded seams are susceptible to an insidious form of corrosion known as selective seam weld corrosion (SSWC).²⁷ SSWC, also called preferential seam corrosion, is corrosion-caused metal loss, either internal or external, of or along an ERW or flash welded seam. The corrosion process attacks the seam bondline region at a higher rate than the surrounding body of the pipe, resulting in a corrosion crevice or groove aligned with the bondline. Figure 8 shows the typical external appearance of SSWC (at arrow). Figure 9 shows typical selective corrosion in cross section.

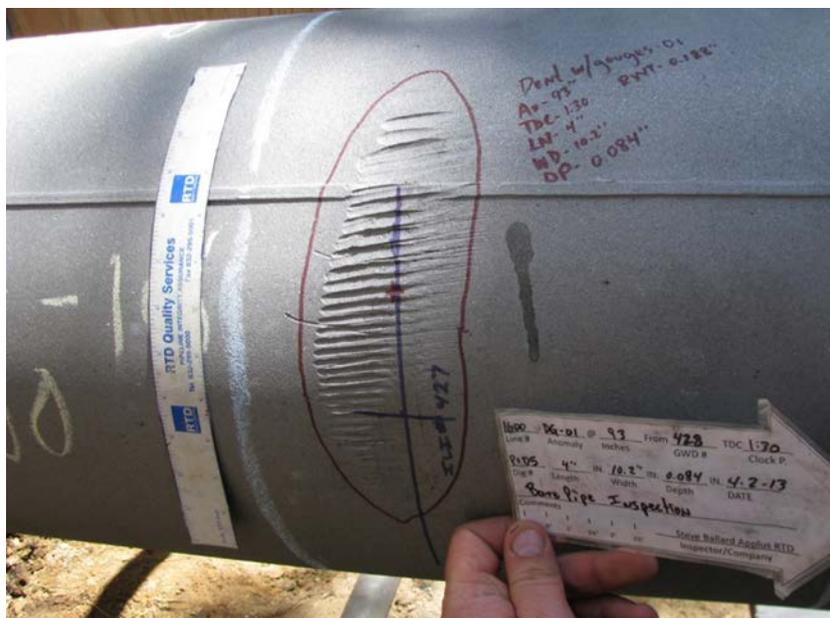
Figure 10. Prior Mechanical Damage Discovered on Line 1600

Mechanical damage results from the pipe being struck by excavating equipment. The damage is in the form of a scrape or gouge, often within a shallow indentation. Mechanical damage, if severe, may result in immediate failure of the pipe. More often, the pipe initially withstands the damage which may then cause a failure weeks, months, or even years after the damage
