Company: San Diego Gas & Electric Company (U 902 M)

Proceeding: 2024 General Rate Case – Track 3

Exhibit: SDG&E-T3-WMPMA-06

SUPPLEMENTAL TESTIMONY OF
JENNIFER KAMINSKY
ON BEHALF OF SAN DIEGO GAS & ELECTRIC COMPANY
(TRACK 3 – ASSET MANAGEMENT AND INSPECTIONS)

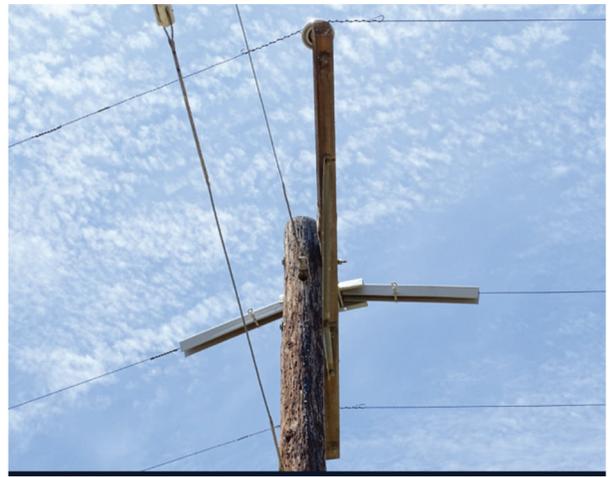
9   Figure JK- 1: P110290, 6/25/2020, Hollow Pole Top and view from below with no visible
10   damage.

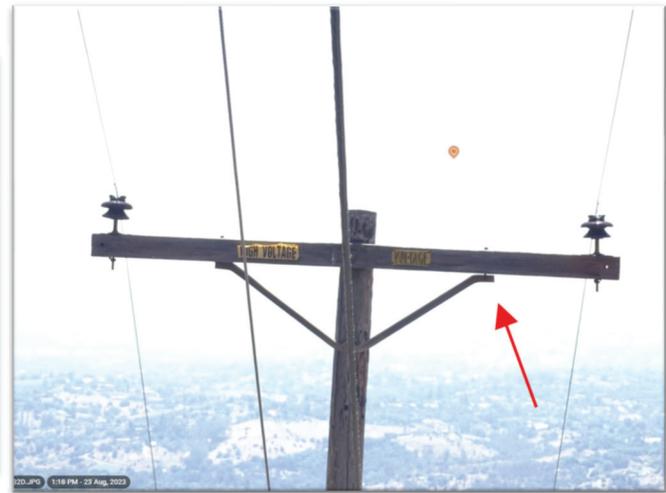
Figure JK- 8: Damaged Crossarm (P176389J)

DIAR Tier 3 – 11/25/2019
